Field Installation and Aging Characteristic Evaluation of  
PA11 Piping Systems at Elevated Pressures

Nashville Gas

***Prepared for: Atofina Chemicals***

*Prepared by Dennis R Jarnecke  
Gas Technology Institute  
Des Plaines, Illinois*

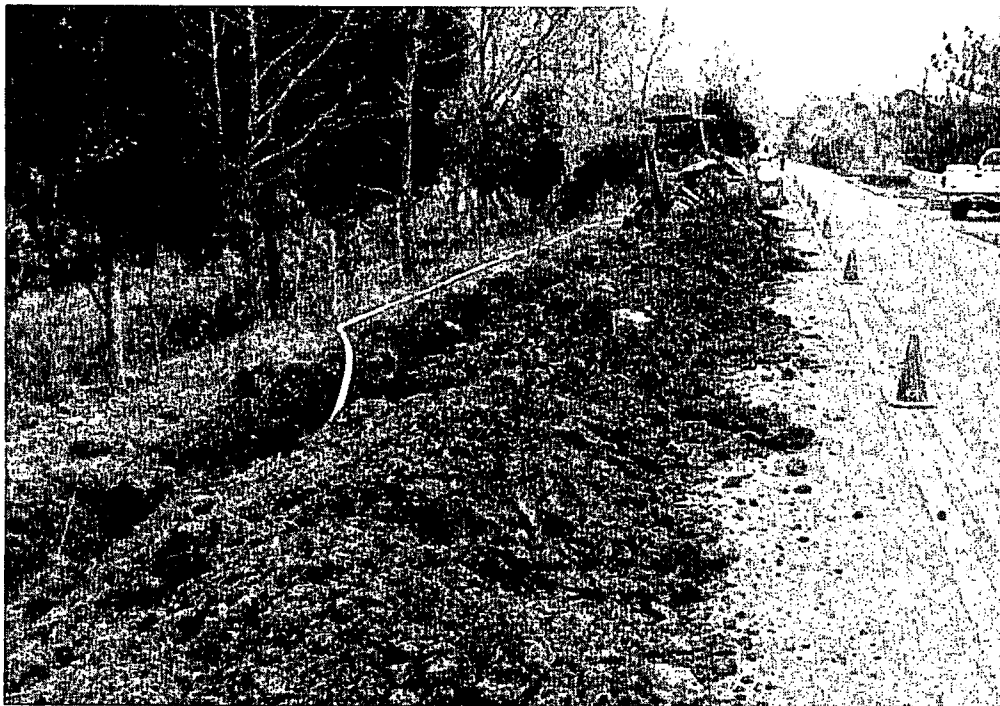
**Installing PA11 pipe in an open trench**

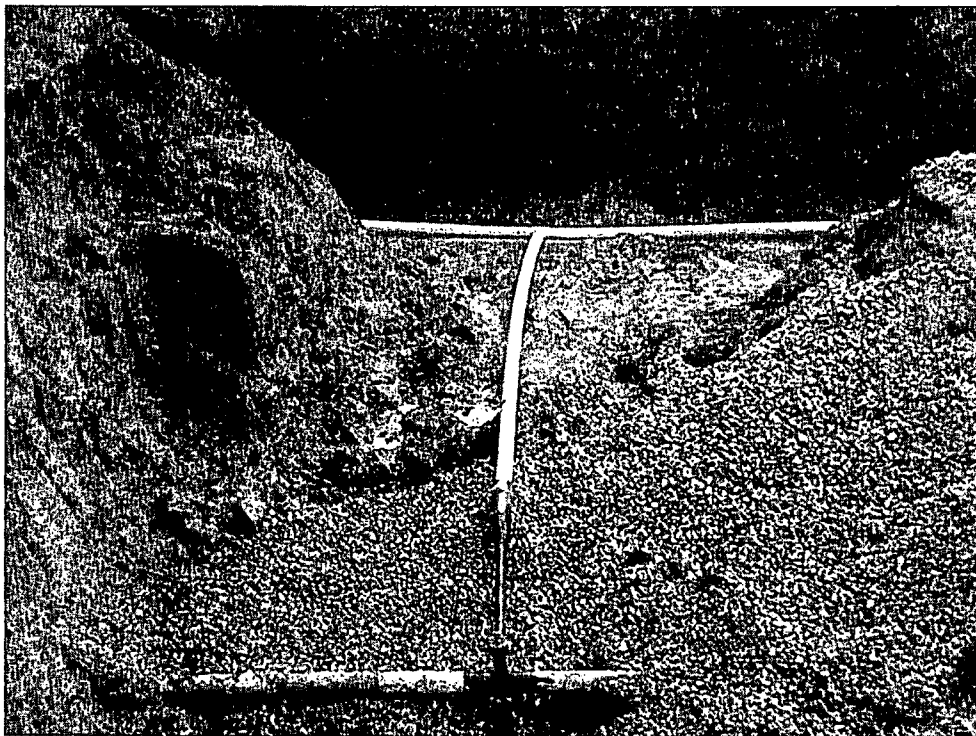
**2" PA11 test leg when originally installed**

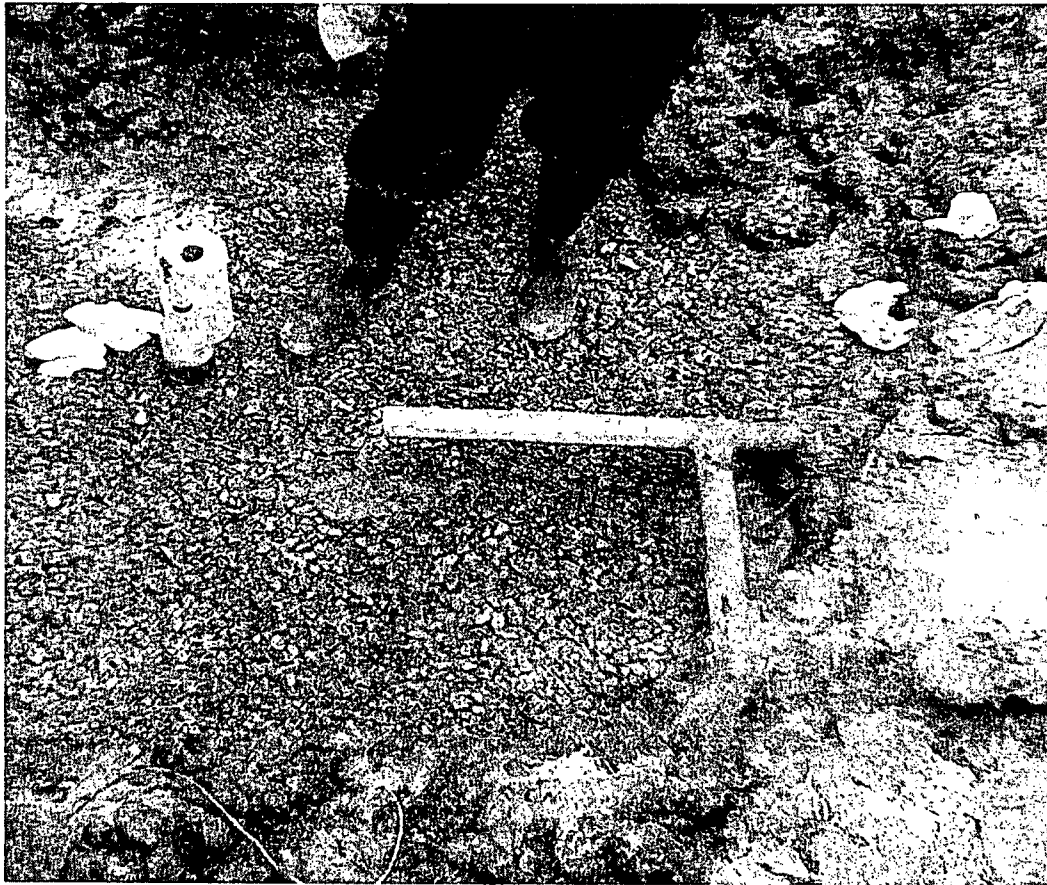
**View after sample removed**

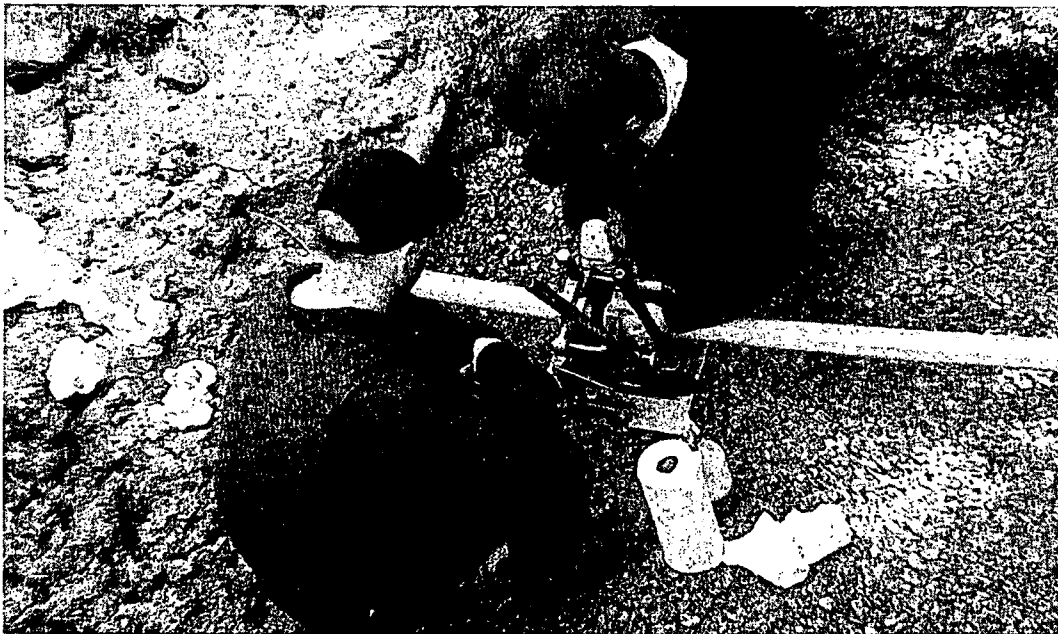
**Fusing on new piece of 2" PA11 pipe to test leg**
